**CITY OF SAN MARCOS  
ADA TRANSITION PLAN  
SIGNALIZED INTERSECTION ASSESSMENT  
AND COMPLIANCE REPORT**

Location ID: 0000000258  
 North-South Cross Street: UNIVERSITY DR  
 East-West Cross Street: EDWARD GARY

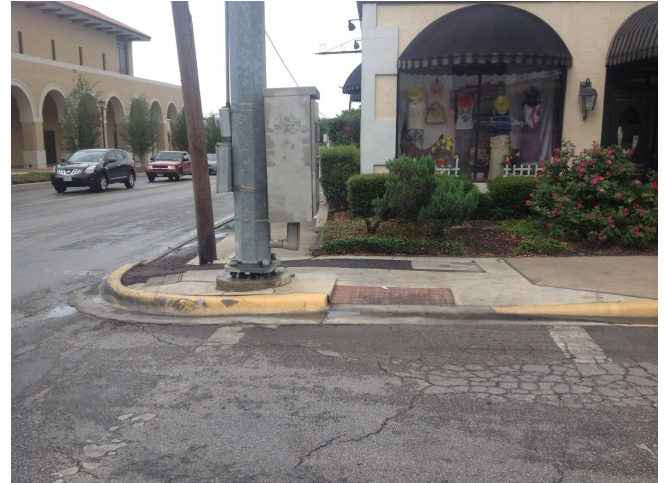
Signalized Intersection: YES  
 Accessible Features: NO  
 Pedestrian Features Accessible: NO

<b>Ramp Elements</b>	Curb ramp provided where an accessible route crosses a barrier:	YES
	Is the slope of the ramp 1:12 or less:	YES
	Transition from curb ramp slope to roadway free from abrupt changes, no greater than 1:20:	NO
	Ramp is at least 36" wide:	YES
	Ramp surface is stable, firm, and slip resistant:	YES
<b>Flare</b>	Flares (if present) are 1:10 or less measured along the curb line; or If landing at top of ramp is not provided flares are 1:12 or less:	YES
<b>Detectable Warning Surface</b>	Curb ramp is located such that it does not project into roadway or parking aisles:	N/A
	Detectable warning is present:	YES
	DWS maintains correct geometric controls; 0.9" diameter domes, 0.2" in height, spaced at 2.35" and visually contracts adjacent ramp surface:	YES
<b>Special Ramps</b>	Ramp maintains defined edges parallel to direction of pedestrian travel; maintains 4'x4' turning pad contained in crosswalk; flared sides 24" segment on each side of ramp within crosswalk lines:	N/A

Ramp is located so they will not be obstructed by parked vehicles:	N/A
	Ramp wholly contained within the crosswalk lines:	YES
	If island is present; Island maintains a cut through at street level or ramps on either side with landing between them:	N/A
