**CITY OF SAN MARCOS
ADA TRANSITION PLAN
SIGNALIZED INTERSECTION ASSESSMENT
AND COMPLIANCE REPORT**

Location ID: 0000000264
 North-South Cross Street: HOPKINS ST
 East-West Cross Street: LYNDON B JOHNSON DR

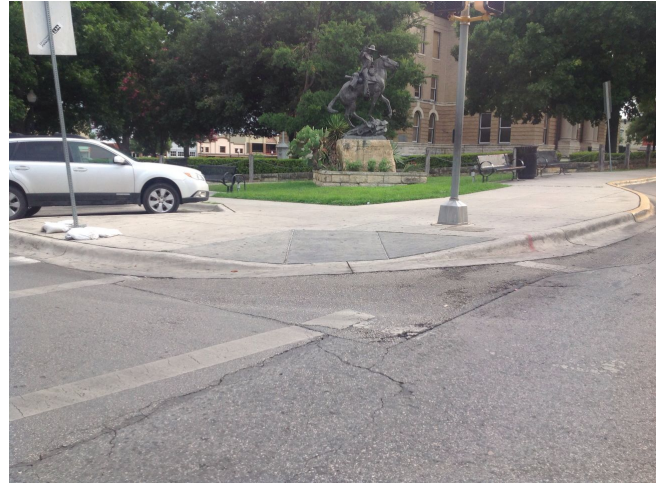
Signalized Intersection: YES
 Accessible Features: NO
 Pedestrian Features Accessible: NO

Ramp Elements	Curb ramp provided where an accessible route crosses a barrier:	YES
	Is the slope of the ramp 1:12 or less:	YES
	Transition from curb ramp slope to roadway free from abrupt changes, no greater than 1:20:	YES
	Ramp is at least 36" wide:	YES
	Ramp surface is stable, firm, and slip resistant:	YES
Flare	Flares (if present) are 1:10 or less measured along the curb line; or If landing at top of ramp is not provided flares are 1:12 or less:	YES
Detectable Warning Surface	Curb ramp is located such that it does not project into roadway or parking aisles:	N/A
	Detectable warning is present:	NO
	DWS maintains correct geometric controls; 0.9" diameter domes, 0.2" in height, spaced at 2.35" and visually contracts adjacent ramp surface:	NO
Special Ramps	Ramp maintains defined edges parallel to direction of pedestrian travel; maintains 4'x4' turning pad contained in crosswalk; flared sides 24" segment on each side of ramp within crosswalk lines:	YES

Ramp is located so they will not be obstructed by parked vehicles:	N/A
	Ramp wholly contained within the crosswalk lines:	YES
	If island is present; Island maintains a cut through at street level or ramps on either side with landing between them:	N/A
