CITY OF SAN MARCOS ADA TRANSITION PLAN SIGNALIZED INTERSECTION ASSESSMENT AND COMPLIANCE REPORT

Location ID: 0000000273
 North-South Cross Street: UNIVERSITY DR
 East-West Cross Street: CM ALLEN PKWY

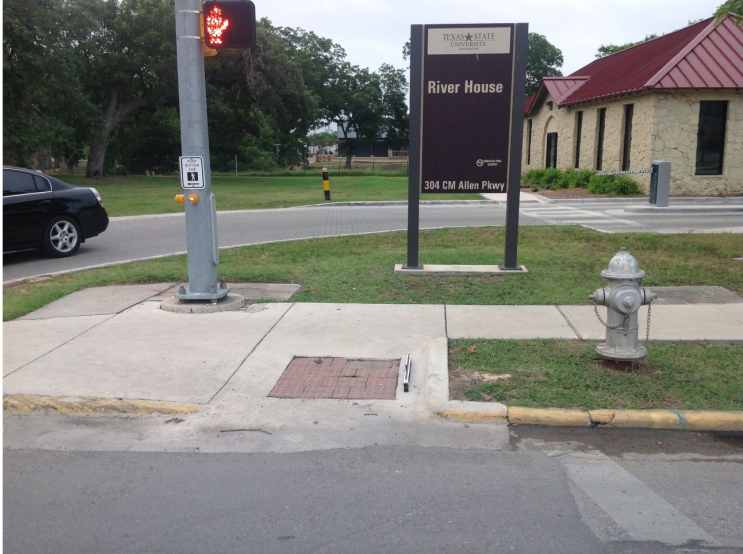
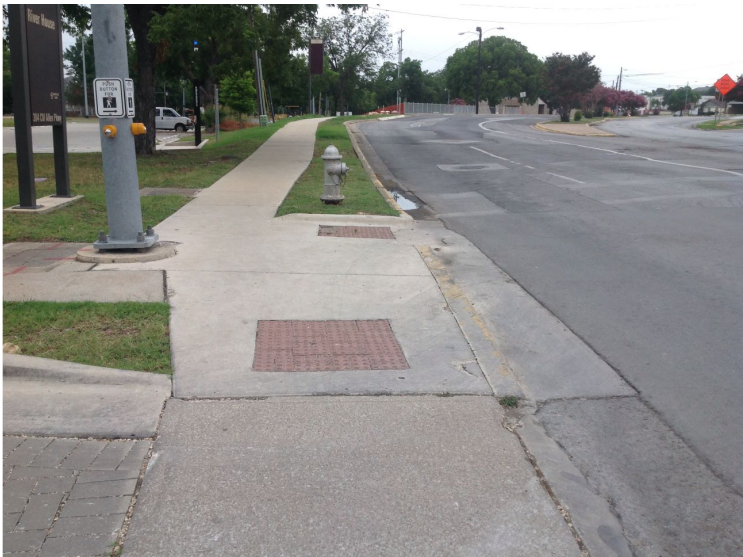
Location Photos

Ramp Elements	Curb ramp provided where an accessible route crosses a barrier:	YES
	Is the slope of the ramp 1:12 or less:	YES
	Transition from curb ramp slope to roadway free from abrupt changes, no greater than 1:20:	YES
	Ramp is at least 36" wide:	YES
	Ramp surface is stable, firm, and slip resistant:	NO
Flare	Flares (if present) are 1:10 or less measured along the curb line; or If landing at top of ramp is not provided flares are 1:12 or less:	NO
Detectable Warning Surface	Curb ramp is located such that it does not project into roadway or parking aisles:	N/A
	Detectable warning is present:	NO
	DWS maintains correct geometric controls; 0.9" diameter domes, 0.2" in height, spaced at 2.35" and visually contracts adjacent ramp surface:	YES
Special Ramps	Ramp maintains defined edges parallel to direction of pedestrian travel; maintains 4'x4' turning pad contained in crosswalk; flared sides 24" segment on each side of ramp within crosswalk lines:	N/A
