**CITY OF SAN MARCOS  
ADA TRANSITION PLAN  
SIGNALIZED INTERSECTION ASSESSMENT  
AND COMPLIANCE REPORT**

Location ID: 0000000276  
 North-South Cross Street: UNIVERSITY DR  
 East-West Cross Street: SESSOM DR

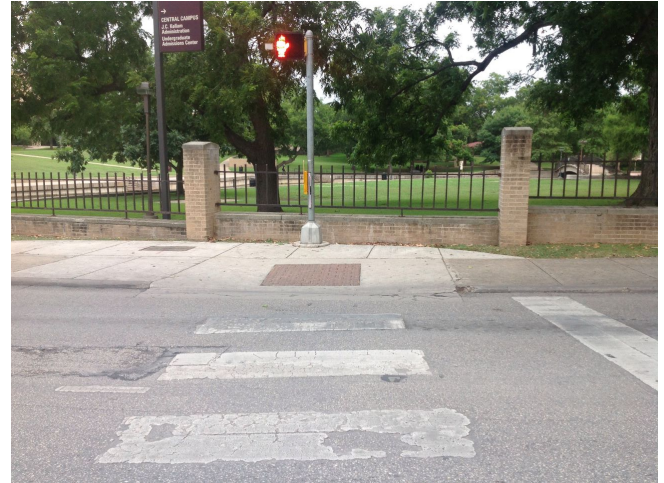
Signalized Intersection: YES  
 Accessible Features: YES  
 Pedestrian Features Accessible: YES

<b>Ramp Elements</b>	Curb ramp provided where an accessible route crosses a barrier:	YES
	Is the slope of the ramp 1:12 or less:	YES
	Transition from curb ramp slope to roadway free from abrupt changes, no greater than 1:20:	YES
	Ramp is at least 36" wide:	YES
	Ramp surface is stable, firm, and slip resistant:	YES
<b>Flare</b>	Flares (if present) are 1:10 or less measured along the curb line; or If landing at top of ramp is not provided flares are 1:12 or less:	YES
<b>Detectable Warning Surface</b>	Curb ramp is located such that it does not project into roadway or parking aisles:	N/A
	Detectable warning is present:	YES
	DWS maintains correct geometric controls; 0.9" diameter domes, 0.2" in height, spaced at 2.35" and visually contrasts adjacent ramp surface:	YES
<b>Special Ramps</b>	Ramp maintains defined edges parallel to direction of pedestrian travel; maintains 4'x4' turning pad contained in crosswalk; flared sides 24" segment on each side of ramp within crosswalk lines:	N/A

Ramp is located so they will not be obstructed by parked vehicles:	N/A
	Ramp wholly contained within the crosswalk lines:	YES
	If island is present; Island maintains a cut through at street level or ramps on either side with landing between them:	N/A
