# CITY OF SAN MARCOS ADA TRANSITION PLAN SIGNALIZED INTERSECTION ASSESSMENT AND COMPLIANCE REPORT

Location ID: 000000284  
 North-South Cross Street: HOPKINS ST  
 East-West Cross Street: CHARLES AUSTIN DR

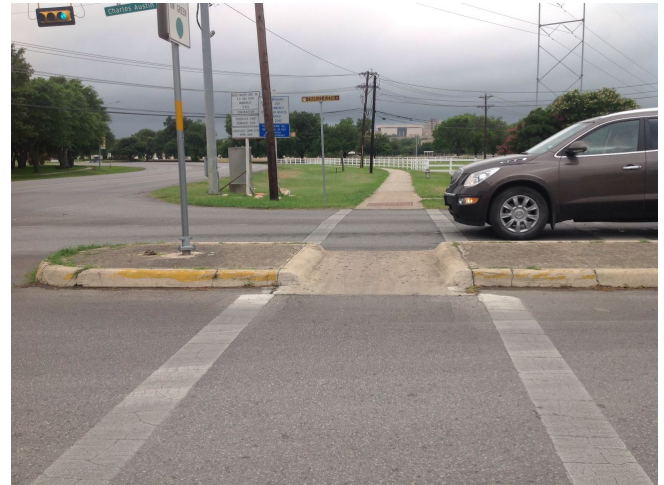
Signalized Intersection: YES  
 Accessible Features: NO  
 Pedestrian Features Accessible: NO

<b>Ramp Elements</b>	Curb ramp provided where an accessible route crosses a barrier:	YES
	Is the slope of the ramp 1:12 or less:	YES
	Transition from curb ramp slope to roadway free from abrupt changes, no greater than 1:20:	YES
	Ramp is at least 36" wide:	YES
	Ramp surface is stable, firm, and slip resistant:	YES
<b>Flare</b>	Flares (if present) are 1:10 or less measured along the curb line; or If landing at top of ramp is not provided flares are 1:12 or less:	N/A
<b>Detectable Warning Surface</b>	Curb ramp is located such that it does not project into roadway or parking aisles:	N/A
	Detectable warning is present:	NO
	DWS maintains correct geometric controls; 0.9" diameter domes, 0.2" in height, spaced at 2.35" and visually contrasts adjacent ramp surface:	NO
<b>Special Ramps</b>	Ramp maintains defined edges parallel to direction of pedestrian travel; maintains 4'x4' turning pad contained in crosswalk; flared sides 24" segment on each side of ramp within crosswalk lines:	N/A

Ramp is located so they will not be obstructed by parked vehicles:	N/A
	Ramp wholly contained within the crosswalk lines:	YES
	If island is present; Island maintains a cut through at street level or ramps on either side with landing between them:	YES
