**CITY OF SAN MARCOS
ADA TRANSITION PLAN
SIGNALIZED INTERSECTION ASSESSMENT
AND COMPLIANCE REPORT**

Location ID: 0000000286
 North-South Cross Street: THORPE LN
 East-West Cross Street: HOPKINS ST

Location ID: 0000000286

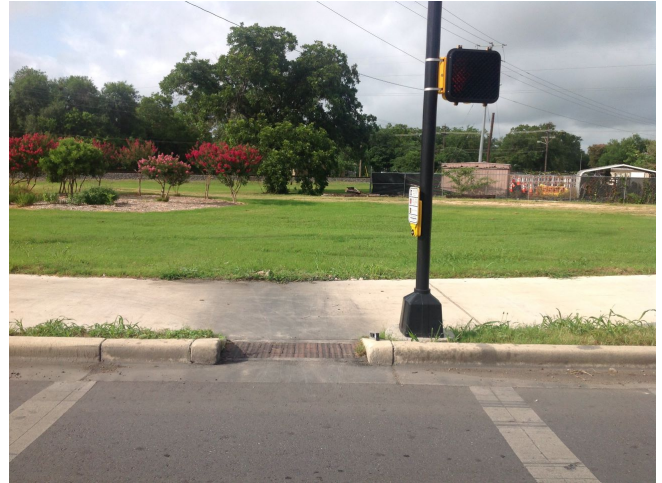
Signalized Intersection: YES
 Accessible Features: YES
 Pedestrian Features Accessible: NO

Ramp Elements	Curb ramp provided where an accessible route crosses a barrier:	YES
	Is the slope of the ramp 1:12 or less:	YES
	Transition from curb ramp slope to roadway free from abrupt changes, no greater than 1:20:	YES
	Ramp is at least 36" wide:	YES
	Ramp surface is stable, firm, and slip resistant:	YES
Flare	Flares (if present) are 1:10 or less measured along the curb line; or If landing at top of ramp is not provided flares are 1:12 or less:	N/A
Detectable Warning Surface	Curb ramp is located such that it does not project into roadway or parking aisles:	
	Detectable warning is present:	YES
	DWS maintains correct geometric controls; 0.9" diameter domes, 0.2" in height, spaced at 2.35" and visually contracts adjacent ramp surface:	YES
Special Ramps	Ramp maintains defined edges parallel to direction of pedestrian travel; maintains 4'x4' turning pad contained in crosswalk; flared sides 24" segment on each side of ramp within crosswalk lines:	N/A

Ramp is located so they will not be obstructed by parked vehicles:	N/A
	Ramp wholly contained within the crosswalk lines:	YES
	If island is present; Island maintains a cut through at street level or ramps on either side with landing between them:	N/A
