CITY OF SAN MARCOS ADA TRANSITION PLAN SIGNALIZED INTERSECTION ASSESSMENT AND COMPLIANCE REPORT

Location ID: 0000000287
 North-South Cross Street: THORPE LN
 East-West Cross Street: HOPKINS ST

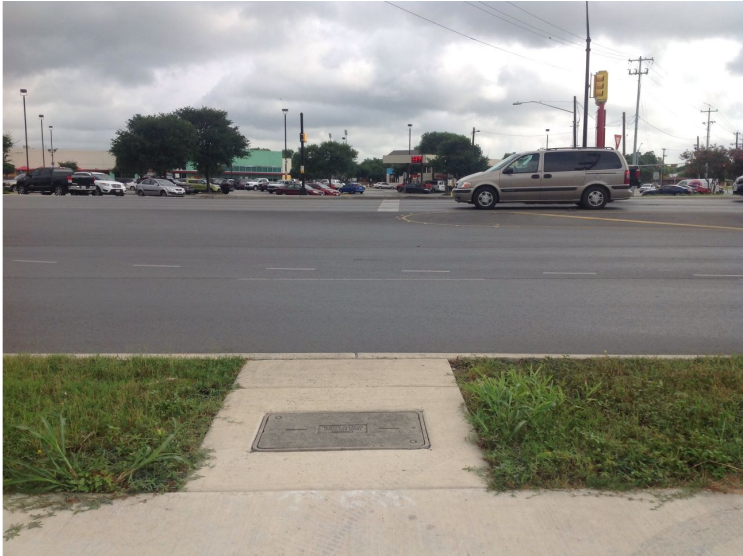
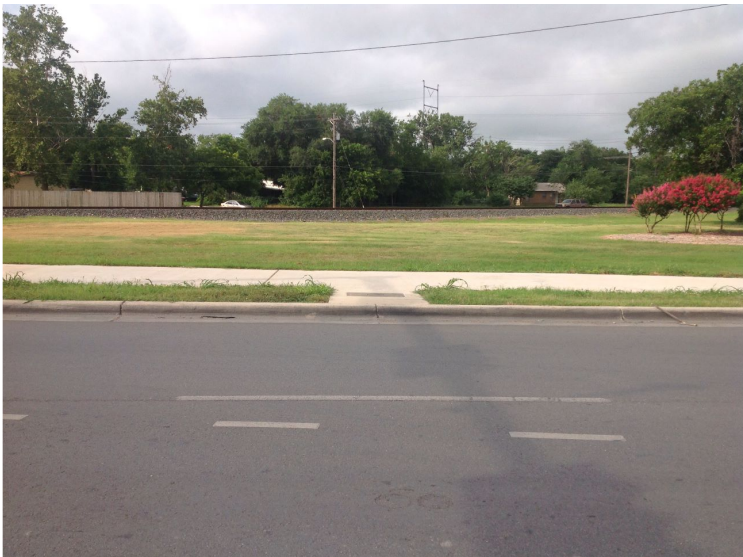
Location Photos

Ramp Elements	Curb ramp provided where an accessible route crosses a barrier:	NO
	Is the slope of the ramp 1:12 or less:	NO
	Transition from curb ramp slope to roadway free from abrupt changes, no greater than 1:20:	NO
	Ramp is at least 36" wide:	NO
	Ramp surface is stable, firm, and slip resistant:	NO
Flare	Flares (if present) are 1:10 or less measured along the curb line; or If landing at top of ramp is not provided flares are 1:12 or less:	NO
Detectable Warning Surface	Curb ramp is located such that it does not project into roadway or parking aisles:	N/A
	Detectable warning is present:	NO
	DWS maintains correct geometric controls; 0.9" diameter domes, 0.2" in height, spaced at 2.35" and visually contracts adjacent ramp surface:	NO
Special Ramps	Ramp maintains defined edges parallel to direction of pedestrian travel; maintains 4'x4' turning pad contained in crosswalk; flared sides 24" segment on each side of ramp within crosswalk lines:	N/A
