**CITY OF SAN MARCOS
ADA TRANSITION PLAN
SIGNALIZED INTERSECTION ASSESSMENT
AND COMPLIANCE REPORT**

Location ID: 000000289
 North-South Cross Street: THORPE LN
 East-West Cross Street: ROBBIE LN

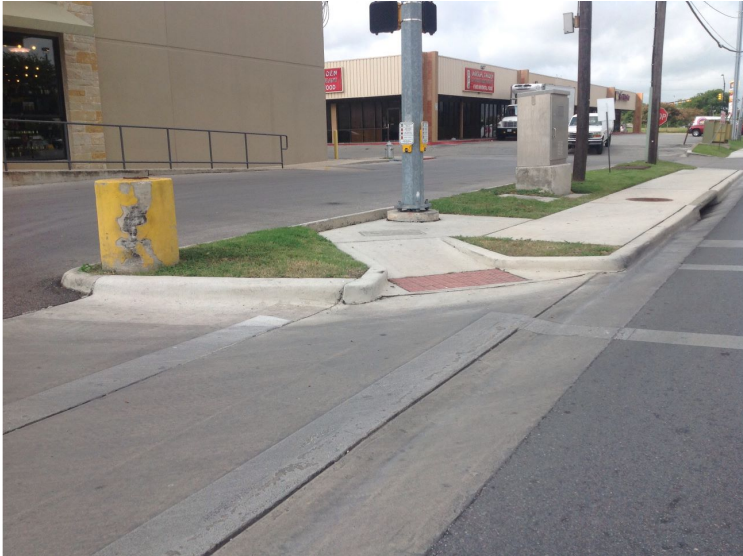
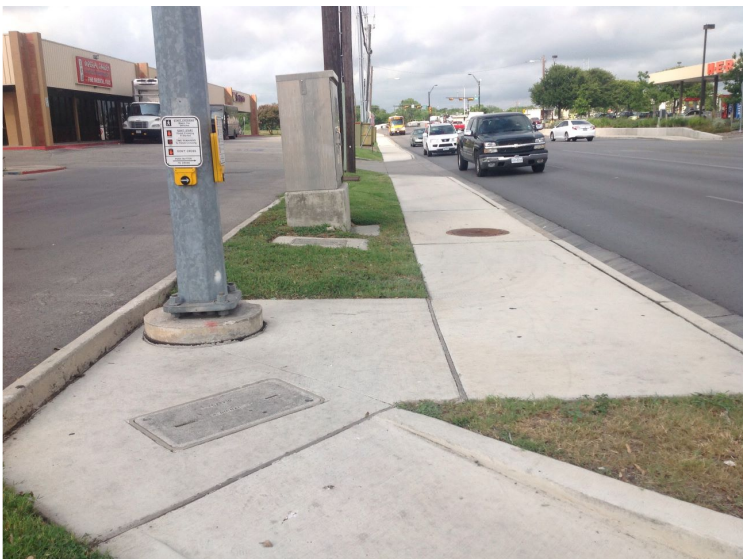
Location Photos

Ramp Elements	Curb ramp provided where an accessible route crosses a barrier:	YES
	Is the slope of the ramp 1:12 or less:	NO
	Transition from curb ramp slope to roadway free from abrupt changes, no greater than 1:20:	YES
	Ramp is at least 36" wide:	YES
	Ramp surface is stable, firm, and slip resistant:	YES
Flare	Flares (if present) are 1:10 or less measured along the curb line; or If landing at top of ramp is not provided flares are 1:12 or less:	N/A
Detectable Warning Surface	Curb ramp is located such that it does not project into roadway or parking aisles:	N/A
	Detectable warning is present:	YES
	DWS maintains correct geometric controls; 0.9" diameter domes, 0.2" in height, spaced at 2.35" and visually contracts adjacent ramp surface:	YES
Special Ramps	Ramp maintains defined edges parallel to direction of pedestrian travel; maintains 4'x4' turning pad contained in crosswalk; flared sides 24" segment on each side of ramp within crosswalk lines:	NO

Ramp is located so they will not be obstructed by parked vehicles:	YES
	Ramp wholly contained within the crosswalk lines:	YES
	If island is present; Island maintains a cut through at street level or ramps on either side with landing between them:	N/A
