**CITY OF SAN MARCOS
ADA TRANSITION PLAN
SIGNALIZED INTERSECTION ASSESSMENT
AND COMPLIANCE REPORT**

Location ID: 0000000294
 North-South Cross Street: POST RD
 East-West Cross Street: AQUARENA SPRINGS DR

Date of Evaluation: 6/27/2014

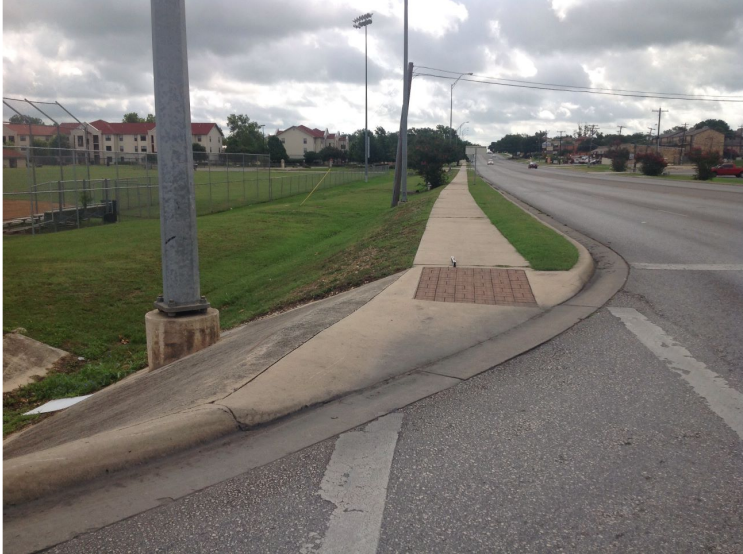
Location Photos

Ramp Elements	Curb ramp provided where an accessible route crosses a barrier:	YES
	Is the slope of the ramp 1:12 or less:	YES
	Transition from curb ramp slope to roadway free from abrupt changes, no greater than 1:20:	NO
	Ramp is at least 36" wide:	YES
	Ramp surface is stable, firm, and slip resistant:	YES
Flare	Flares (if present) are 1:10 or less measured along the curb line; or If landing at top of ramp is not provided flares are 1:12 or less:	YES
Detectable Warning Surface	Curb ramp is located such that it does not project into roadway or parking aisles:	N/A
	Detectable warning is present:	YES
	DWS maintains correct geometric controls; 0.9" diameter domes, 0.2" in height, spaced at 2.35" and visually contracts adjacent ramp surface:	YES
Special Ramps	Ramp maintains defined edges parallel to direction of pedestrian travel; maintains 4'x4' turning pad contained in crosswalk; flared sides 24" segment on each side of ramp within crosswalk lines:	N/A

Ramp is located so they will not be obstructed by parked vehicles:	N/A
	Ramp wholly contained within the crosswalk lines:	YES
	If island is present; Island maintains a cut through at street level or ramps on either side with landing between them:	N/A
