CITY OF SAN MARCOS ADA TRANSITION PLAN SIGNALIZED INTERSECTION ASSESSMENT AND COMPLIANCE REPORT

Location ID: 0000000295
 North-South Cross Street: POST RD
 East-West Cross Street: UHLAND RD

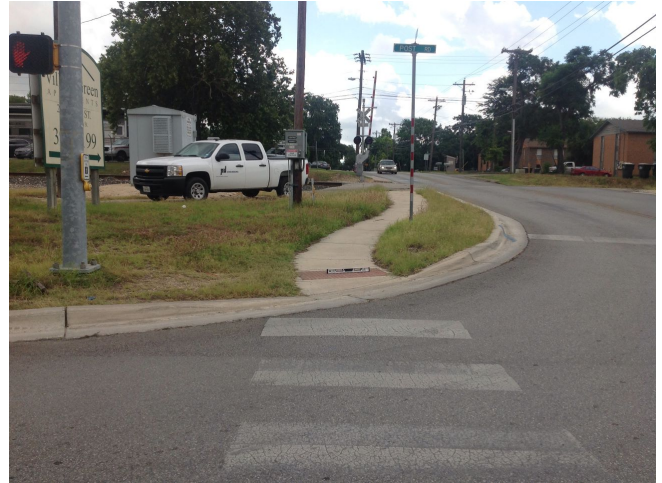
Signalized Intersection: YES
 Accessible Features: YES
 Pedestrian Features Accessible: NO

Ramp Elements	Curb ramp provided where an accessible route crosses a barrier:	YES
	Is the slope of the ramp 1:12 or less:	YES
	Transition from curb ramp slope to roadway free from abrupt changes, no greater than 1:20:	YES
	Ramp is at least 36" wide:	YES
	Ramp surface is stable, firm, and slip resistant:	YES
Flare	Flares (if present) are 1:10 or less measured along the curb line; or If landing at top of ramp is not provided flares are 1:12 or less:	N/A
Detectable Warning Surface	Curb ramp is located such that it does not project into roadway or parking aisles:	N/A
	Detectable warning is present:	YES
	DWS maintains correct geometric controls; 0.9" diameter domes, 0.2" in height, spaced at 2.35" and visually contrasts adjacent ramp surface:	YES
Special Ramps	Ramp maintains defined edges parallel to direction of pedestrian travel; maintains 4'x4' turning pad contained in crosswalk; flared sides 24" segment on each side of ramp within crosswalk lines:	N/A

Ramp is located so they will not be obstructed by parked vehicles:	N/A
	Ramp wholly contained within the crosswalk lines:	YES
	If island is present; Island maintains a cut through at street level or ramps on either side with landing between them:	N/A
