CITY OF SAN MARCOS ADA TRANSITION PLAN SIGNALIZED INTERSECTION ASSESSMENT AND COMPLIANCE REPORT

Location ID: 0000000307
 North-South Cross Street: SBFR IH 35
 East-West Cross Street: TX HWY 80

Location ID: 0000000307

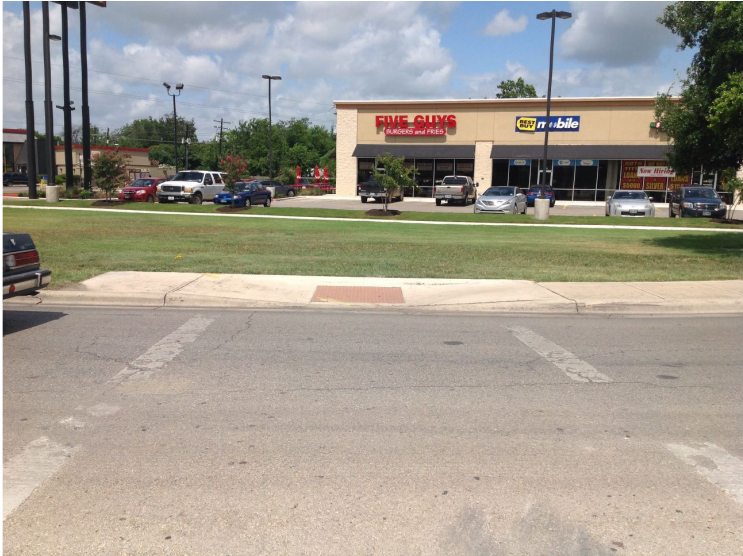
Location Photos

Ramp Elements	Curb ramp provided where an accessible route crosses a barrier:	YES
	Is the slope of the ramp 1:12 or less:	YES
	Transition from curb ramp slope to roadway free from abrupt changes, no greater than 1:20:	NO
	Ramp is at least 36" wide:	YES
	Ramp surface is stable, firm, and slip resistant:	YES
Flare	Flares (if present) are 1:10 or less measured along the curb line; or If landing at top of ramp is not provided flares are 1:12 or less:	N/A
Detectable Warning Surface	Curb ramp is located such that it does not project into roadway or parking aisles:	N/A
	Detectable warning is present:	YES
	DWS maintains correct geometric controls; 0.9" diameter domes, 0.2" in height, spaced at 2.35" and visually contracts adjacent ramp surface:	YES
Special Ramps	Ramp maintains defined edges parallel to direction of pedestrian travel; maintains 4'x4' turning pad contained in crosswalk; flared sides 24" segment on each side of ramp within crosswalk lines:	YES
