CITY OF SAN MARCOS ADA TRANSITION PLAN SIGNALIZED INTERSECTION ASSESSMENT AND COMPLIANCE REPORT

Location ID: 0000000314
 North-South Cross Street: CLAREWOOD DR
 East-West Cross Street: TX HWY 80

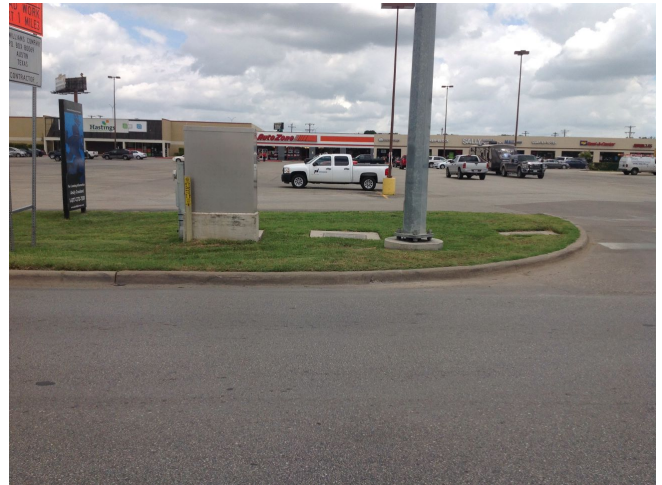
Signalized Intersection: YES
 Accessible Features: NO
 Pedestrian Features Accessible: NO

Ramp Elements	Curb ramp provided where an accessible route crosses a barrier:	NO
	Is the slope of the ramp 1:12 or less:	NO
	Transition from curb ramp slope to roadway free from abrupt changes, no greater than 1:20:	NO
	Ramp is at least 36" wide:	NO
	Ramp surface is stable, firm, and slip resistant:	NO
Flare	Flares (if present) are 1:10 or less measured along the curb line; or If landing at top of ramp is not provided flares are 1:12 or less:	NO
Detectable Warning Surface	Curb ramp is located such that it does not project into roadway or parking aisles:	N/A
	Detectable warning is present:	NO
	DWS maintains correct geometric controls; 0.9" diameter domes, 0.2" in height, spaced at 2.35" and visually contracts adjacent ramp surface:	NO
Special Ramps	Ramp maintains defined edges parallel to direction of pedestrian travel; maintains 4'x4' turning pad contained in crosswalk; flared sides 24" segment on each side of ramp within crosswalk lines:	N/A
