**DOWNTOWN PLAZA & BANDSTAND
500 Main Plaza
New Braunfels, TX 78130**

ADA SELF-EVALUATION FACILITY SURVEY

New Braunfels Downtown Plaza & Bandstand

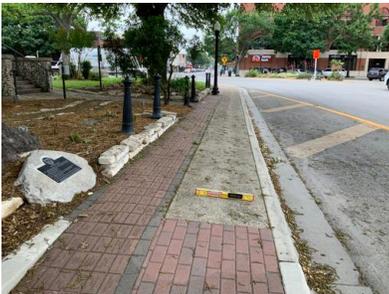
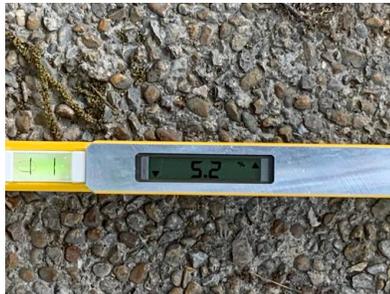
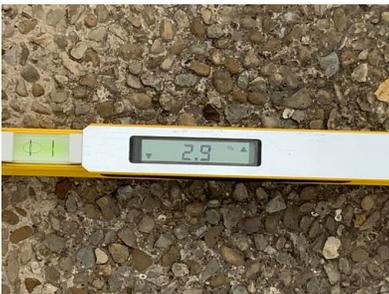
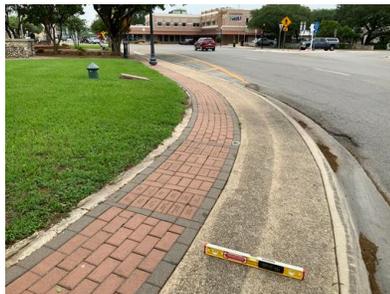
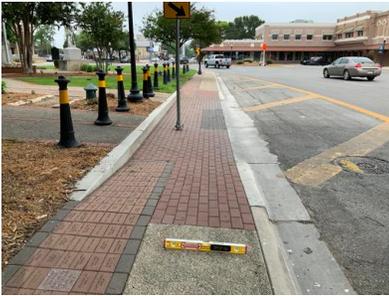
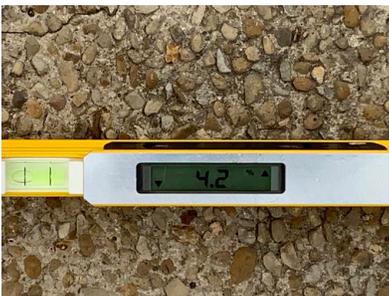
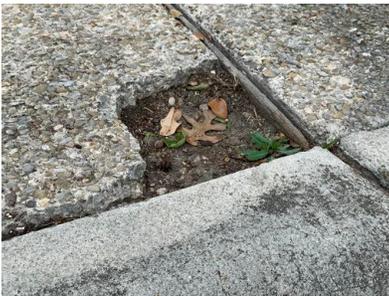
#5 Priority 1: Accessible Routes

Location
Perimeter Sidewalk

Description
Entire perimeter sidewalk has cross slopes up to 5.6% and excessive changes in level.

Recommendation: Remove and replace sidewalk.
584' x 3' (1752 SF)

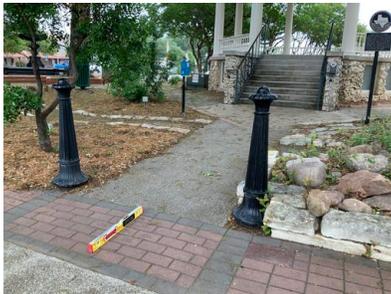
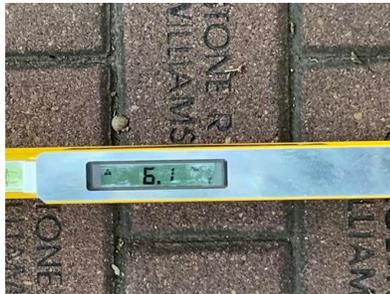
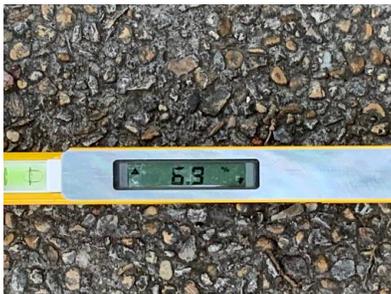
#6 Priority 1: Accessible Routes

Location
Sidewalk to Bandstand
Stairs

Description
The route from the perimeter sidewalk to the bandstand stairs has running slope of up to 6.9%.

Recommendation: Replace sidewalk. (75 SF)

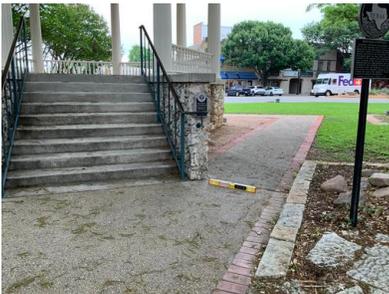
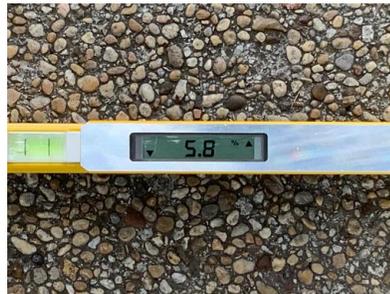
#8 Priority 1: Accessible Routes

Bandstand Perimeter
Sidewalk

The sidewalk around the bandstand has cross slopes ranging from 2.5% to 5.8% and openings greater than 1/2".

Recommendation: Remove and replace sidewalk. (480 SF)

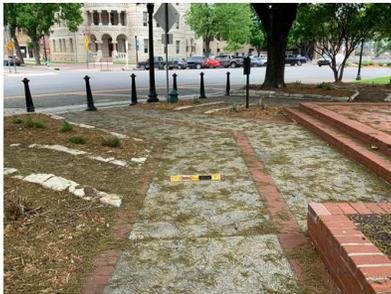
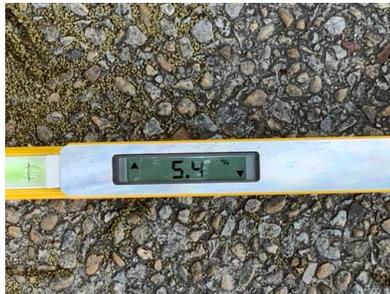
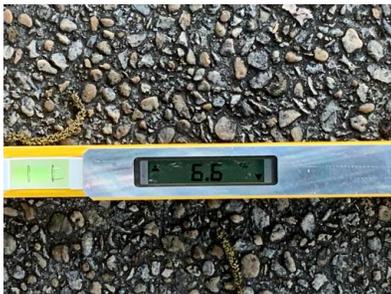
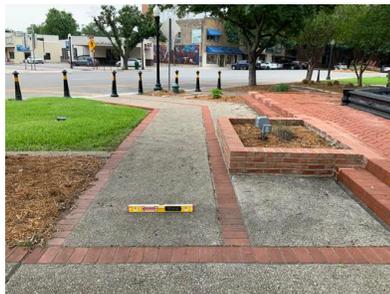
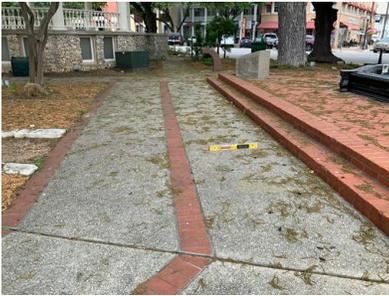
#10 Priority 1: Accessible Routes

Location
Fountain Perimeter Sidewalk

Description
The sidewalk to and around the fountain has a cross slope ranging from 2.7% to 8%.

Recommendation: Remove and replace sidewalk. (600 SF)

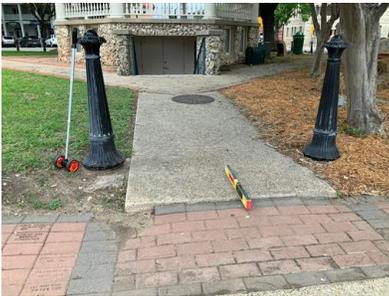
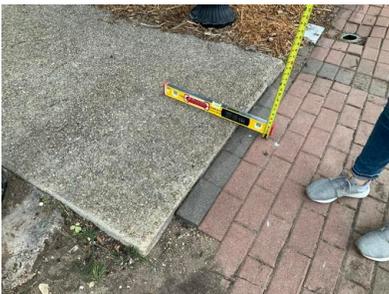
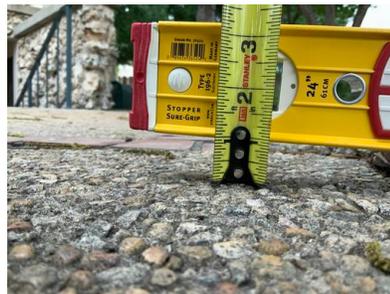
#11 Priority 1: Accessible Routes

Sidewalk to Rear Bandstand

The route from the perimeter sidewalk to the back of the bandstand has multiple changes in level greater than 1/2".

Recommendation: Replace sidewalk. (75 SF)

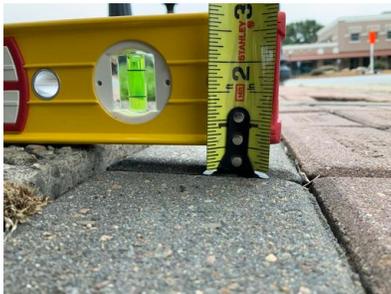
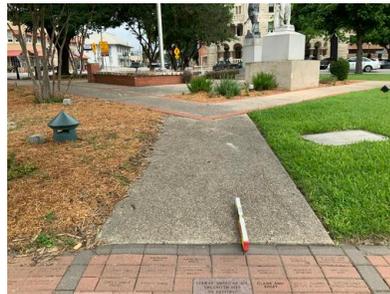
#12 Priority 1: Accessible Routes

Location
South Sidewalk to Memorial

Description
The south sidewalk has an abrupt change in level of 1/2" at the perimeter sidewalk.

Recommendation: Grind edge to a 1:2 slope.

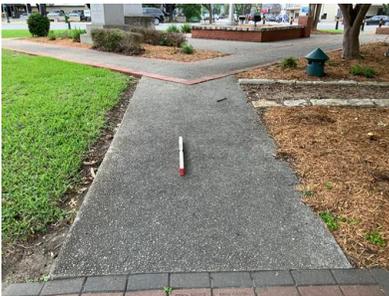
#13 Priority 1: Accessible Routes

North Sidewalk to Memorial

Recommendation: Remove and replace sidewalk. (75 SF)

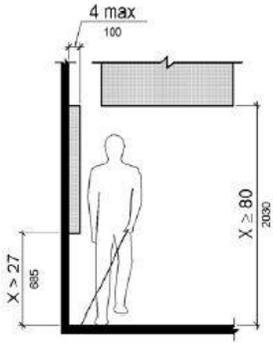
Figure 307.2 Limits of Protruding Objects

#15 Priority 2: Protruding Objects

The north side of the sidewalk around the memorial has low tree branches with an overhead clearance of only 70".

Recommendation: Trim tree branches.

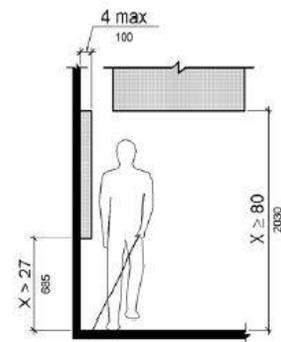
Figure 307.2 Limits of Protruding Objects

#17 Priority 2: Protruding Objects

Description
The route from the perimeter sidewalk to the back of the bandstand has low tree branches with an overhead clearance of only 74".

Recommendation: Trim tree branches.

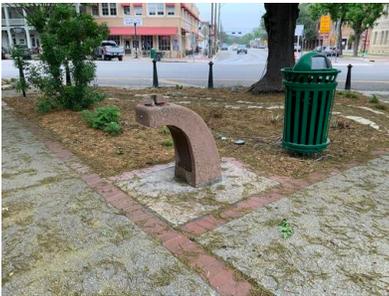
#9 Priority 4: Drinking Fountains

The single drinking fountain is accessible, but no standing height fountain is provided.

Recommendation: Install a second fountain with the spout 38" to 43" high.
