**PRINCE SOLMS PARK  
100 Liebscher Drive  
New Braunfels, TX 78130**

This report has been developed as part of an overall self-evaluation and transition planning effort undertaken by the City of New Braunfels and as required by the Americans with Disabilities Act Title II Regulations for state and local government entities. The conditions cited within this report represent the findings of our team at the time of evaluation on September 17, 2019. Our survey included public areas and other areas where city programs are offered.

# Prince Solms Park

Oct 14, 2019

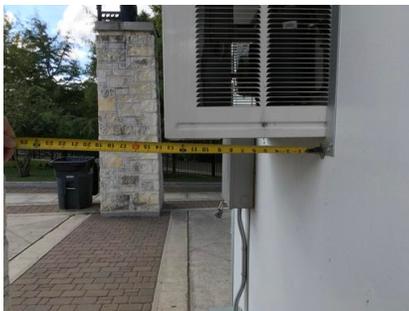
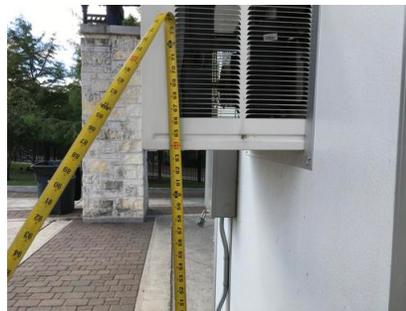
## #82 Priority 2: Protruding Objects

Gateway Booth

Recommendation: Install some type of cane barrier below (bollards, railing, etc.).
