CITY OF SAN MARCOS ADA TRANSITION PLAN SIGNALIZED INTERSECTION ASSESSMENT AND COMPLIANCE REPORT

Location ID: 0000000163
 North-South Cross Street: THORPE LN
 East-West Cross Street: EASTWOOD ST

Date of Evaluation: 6/27/2014

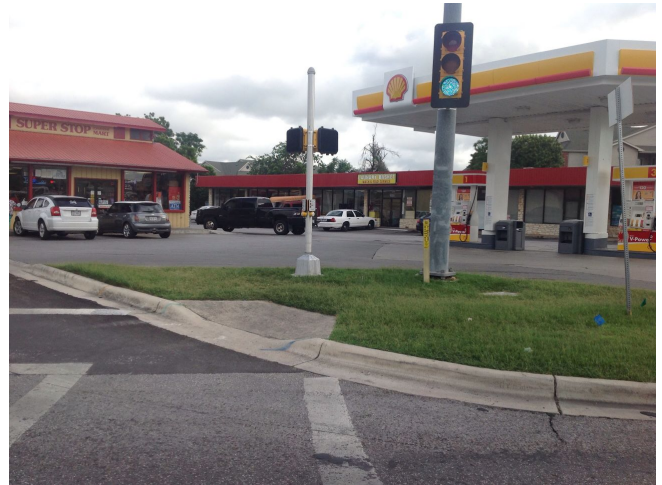
Signalized Intersection: YES
 Accessible Features: YES
 Pedestrian Features Accessible: NO

Ramp Elements	Curb ramp provided where an accessible route crosses a barrier:	YES
	Is the slope of the ramp 1:12 or less:	NO
	Transition from curb ramp slope to roadway free from abrupt changes, no greater than 1:20:	NO
	Ramp is at least 36" wide:	NO
	Ramp surface is stable, firm, and slip resistant:	YES
Flare	Flares (if present) are 1:10 or less measured along the curb line; or If landing at top of ramp is not provided flares are 1:12 or less:	NO
Detectable Warning Surface	Curb ramp is located such that it does not project into roadway or parking aisles:	N/A
	Detectable warning is present:	NO
	DWS maintains correct geometric controls; 0.9" diameter domes, 0.2" in height, spaced at 2.35" and visually contracts adjacent ramp surface:	NO
Special Ramps	Ramp maintains defined edges parallel to direction of pedestrian travel; maintains 4'x4' turning pad contained in crosswalk; flared sides 24" segment on each side of ramp within crosswalk lines:	YES

Ramp is located so they will not be obstructed by parked vehicles:	N/A
	Ramp wholly contained within the crosswalk lines:	YES
	If island is present; Island maintains a cut through at street level or ramps on either side with landing between them:	N/A
