# CITY OF SAN MARCOS ADA TRANSITION PLAN SIGNALIZED INTERSECTION ASSESSMENT AND COMPLIANCE REPORT

Location ID: 0000000267  
 North-South Cross Street: SAN ANTONIO ST  
 East-West Cross Street: GUADALUPE ST

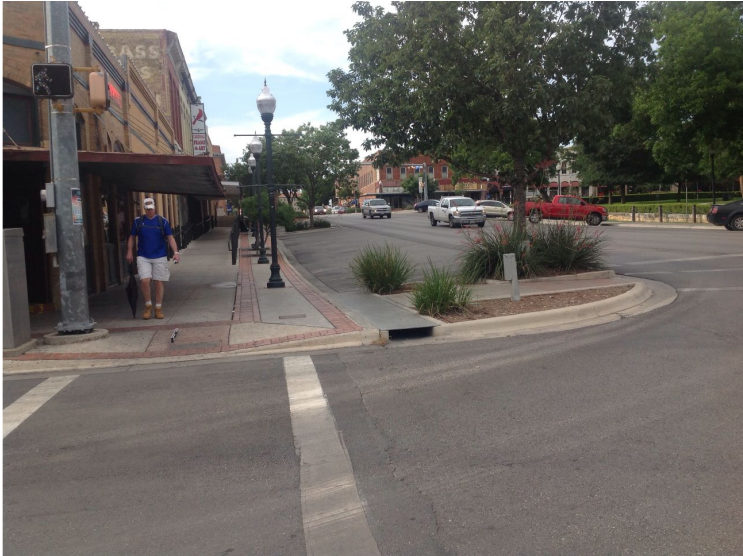
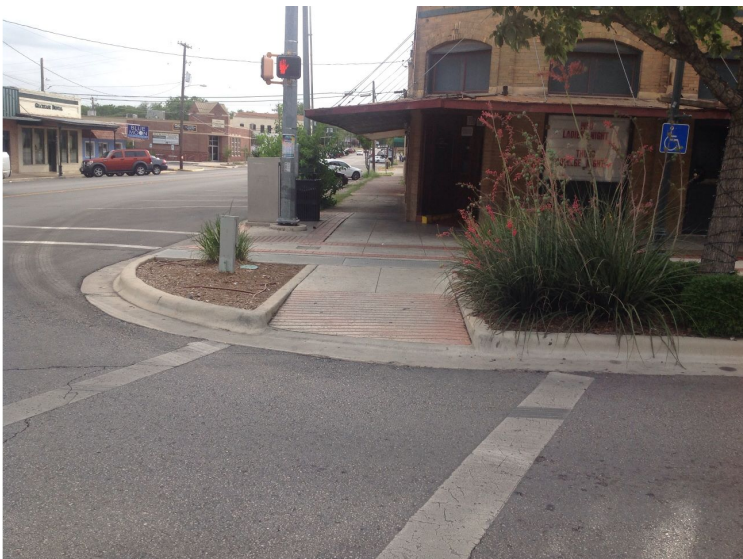
<b>Ramp Elements</b>	Curb ramp provided where an accessible route crosses a barrier:	YES
	Is the slope of the ramp 1:12 or less:	YES
	Transition from curb ramp slope to roadway free from abrupt changes, no greater than 1:20:	NO
	Ramp is at least 36" wide:	YES
	Ramp surface is stable, firm, and slip resistant:	YES
<b>Flare</b>	Flares (if present) are 1:10 or less measured along the curb line; or If landing at top of ramp is not provided flares are 1:12 or less:	YES
<b>Detectable Warning Surface</b>	Curb ramp is located such that it does not project into roadway or parking aisles:	YES
	Detectable warning is present:	NO
	DWS maintains correct geometric controls; 0.9" diameter domes, 0.2" in height, spaced at 2.35" and visually contracts adjacent ramp surface:	NO
<b>Special Ramps</b>	Ramp maintains defined edges parallel to direction of pedestrian travel; maintains 4'x4' turning pad contained in crosswalk; flared sides 24" segment on each side of ramp within crosswalk lines:	N/A
