**CITY OF SAN MARCOS
ADA TRANSITION PLAN
SIGNALIZED INTERSECTION ASSESSMENT
AND COMPLIANCE REPORT**

Location ID: 0000000281
 North-South Cross Street: SESSOM DR
 East-West Cross Street: LBJ DR

Date of Evaluation: 6/27/2014

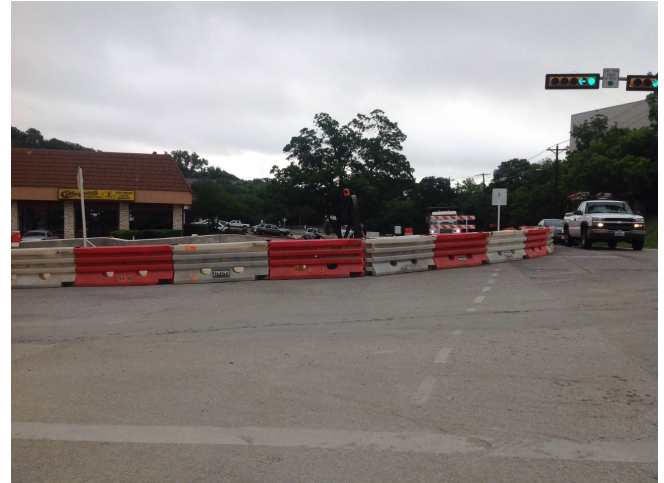
Signalized Intersection: YES
 Accessible Features: NO
 Pedestrian Features Accessible: NO

Ramp Elements	Curb ramp provided where an accessible route crosses a barrier:	NO
	Is the slope of the ramp 1:12 or less:	NO
	Transition from curb ramp slope to roadway free from abrupt changes, no greater than 1:20:	NO
	Ramp is at least 36" wide:	NO
	Ramp surface is stable, firm, and slip resistant:	NO
Flare	Flares (if present) are 1:10 or less measured along the curb line; or If landing at top of ramp is not provided flares are 1:12 or less:	NO
Detectable Warning Surface	Curb ramp is located such that it does not project into roadway or parking aisles:	N/A
	Detectable warning is present:	NO
	DWS maintains correct geometric controls; 0.9" diameter domes, 0.2" in height, spaced at 2.35" and visually contracts adjacent ramp surface:	NO
Special Ramps	Ramp maintains defined edges parallel to direction of pedestrian travel; maintains 4'x4' turning pad contained in crosswalk; flared sides 24" segment on each side of ramp within crosswalk lines:	N/A

Ramp is located so they will not be obstructed by parked vehicles:	N/A
	Ramp wholly contained within the crosswalk lines:	N/A
	If island is present; Island maintains a cut through at street level or ramps on either side with landing between them:	N/A
