CITY OF SAN MARCOS ADA TRANSITION PLAN SIGNALIZED INTERSECTION ASSESSMENT AND COMPLIANCE REPORT

Location ID: 0000000215
 North-South Cross Street: NBFR IH 35
 East-West Cross Street: SH 123

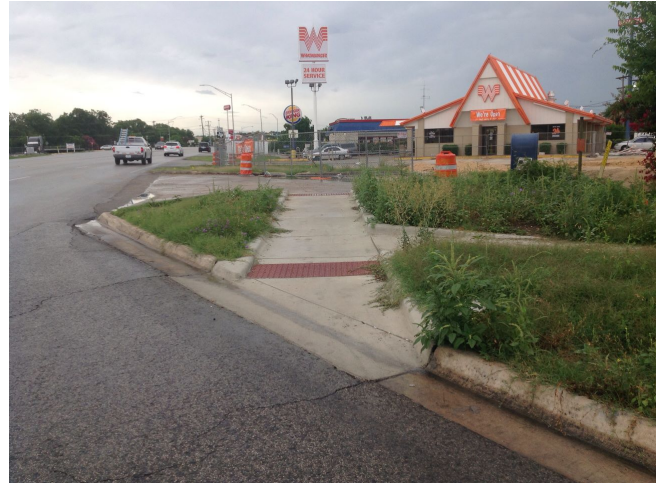
Location Details

Signalized Intersection: YES
 Accessible Features: NO
 Pedestrian Features Accessible: NO
