Utility Conflict Report

| OWNER | Utility | SAWS | Corridor | RIGSBY | SITE PHOTOS |
| | Utility Conflict Description | MANHOLE WITHIN PROPOSED SIDEWALK | | | |

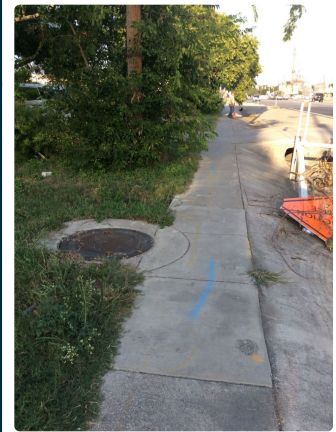
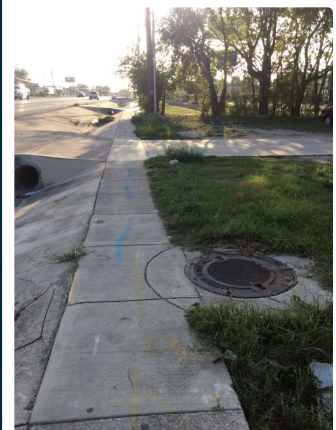
| GENERAL INFO | Utility | SANITARY SEWER | | | |
| | Size and Material | STANDARD MANHOLE, CAST IRON | | | |

| RESOLUTION | Recommended Action | MINIMIZE - PROTECT IN PLACE | | | |
| | Comment | ADJUST MANHOLE LID TO PROPOSED GRADE DURING CONSTRUCTION (1" VERTICAL CHANGE ANTICIPATED) | | | |
