Utility Conflict Report

OWNER	Utility	SAWS	Corridor	SW MILITARY	SITE PHOTOS		
	Contact	ANN PECHE	ID	3081			
GENERAL INFO	Utility	WATER

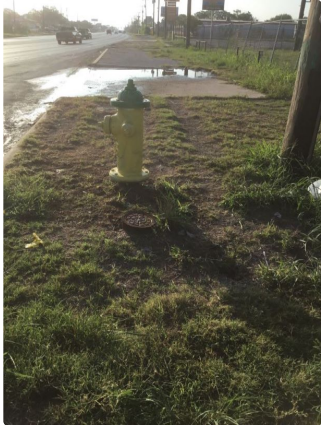
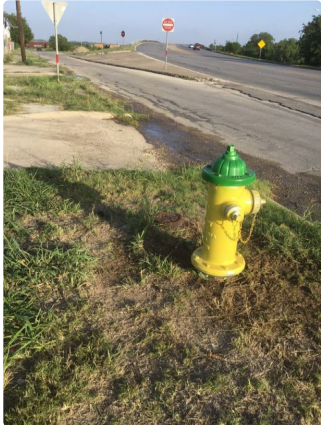
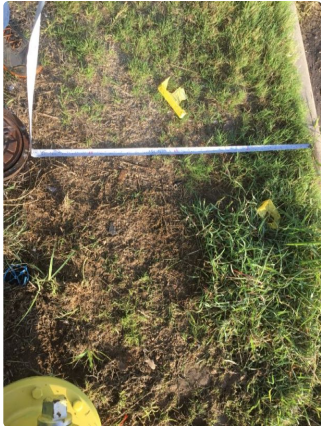
Size and Material	STANDARD WATER VALVE, CAST IRON					
	Accessible Route	ASSET IS INSIDE ACCESSIBLE ROUTE					
	Longitudinal or Crossing	CROSSING					
	Placement Relative to ROW	INSIDE ROW					
LOCATION	Sheet No.	120

Station	506+53.90					
	Offset	29.983					
	Latitude	+29.358974					
	Longitude	-98.56768					
SUE	Level of Investigation Req'd	NONE

Test Hole No	N/A					
	Test Hole Depth	N/A					
RESOLUTION	Recommended Action	NO CONFLICT					
	Estimated Resolution Date	8/14/2018					
	Resolution Status	NO RESOLUTION WAS REQUIRED					
	Comment	Back of curb to meter = 3'-8" Lid thickness = 3.5" Top of valve to surface = 5'-2"					
Date Collected		7/19/2018 8:00:13 AM		Date Modified		11/28/2018 6:59:12 AM
