## Utility Conflict Report

<b>OWNER</b>	<b>Utility</b>	SAWS	<b>Corridor</b>	SW MILITARY	<b>SITE PHOTOS</b>		
	<b>Contact</b>	ANN PECHE	<b>ID</b>	3143			
<b>GENERAL INFO</b>	<b>Utility</b>	SANITARY SEWER

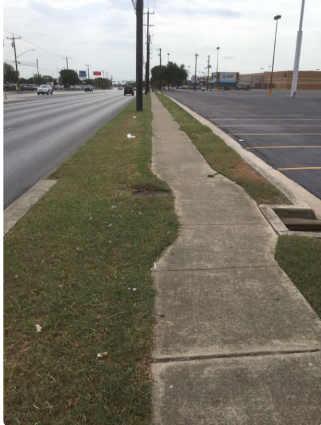
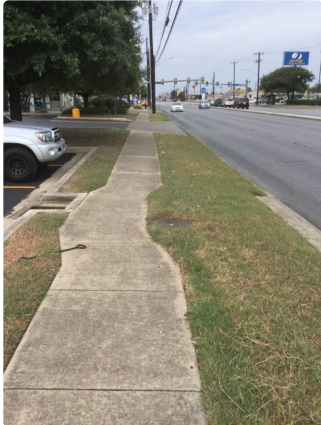
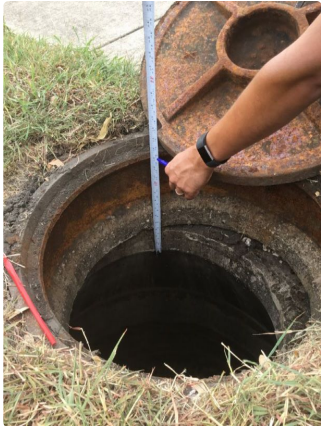
<b>Size and Material</b>	STANDARD MANHOLE, CAST IRON					
	<b>Accessible Route</b>	ASSET IS INSIDE ACCESSIBLE ROUTE					
	<b>Longitudinal or Crossing</b>	CROSSING					
	<b>Placement Relative to ROW</b>	INSIDE ROW					
<b>LOCATION</b>	<b>Sheet No.</b>	173

<b>Test Hole No</b>	N/A					
	<b>Test Hole Depth</b>	N/A					
<b>RESOLUTION</b>	<b>Recommended Action</b>	NO CONFLICT					
	<b>Estimated Resolution Date</b>						
	<b>Resolution Status</b>	NO RESOLUTION WAS REQUIRED					
	<b>Comment</b>	Manhole adjacent to front of sidewalk Sidewalk width = 4'-0" Bottom of cone to surface = 1'-5.5" Lid thickness = 1 1/2"
