Utility Conflict Report

| OWNER | Utility | CPS | Corridor | SW MILITARY | SITE PHOTOS | | |
| GENERAL INFO | Utility | ELECTRIC | | | | | |

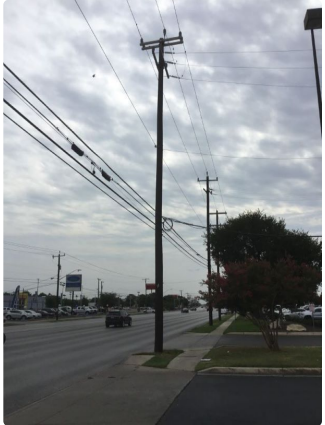
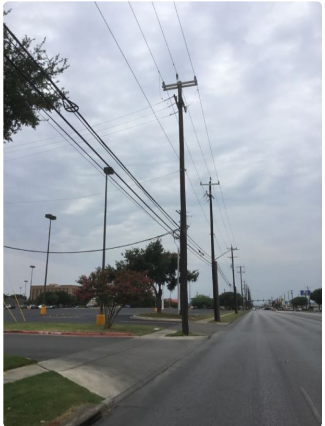
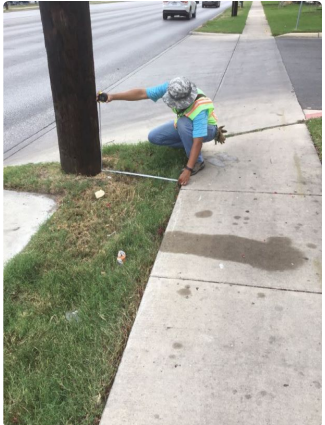
| | Size and Material | STANDARD POWER POLE, TIMBER | | | | | |
| RESOLUTION | Recommended Action | NO CONFLICT | | | | | |
| | Resolution Status | NO RESOLUTION WAS REQUIRED | | | | | |
| | Comment | Pole ID: 491663 Pole to front of sidewalk = 2'-8" Sidewalk width = 4'-3" Pole diameter = 14 1/2" | | | | | |
