Utility Conflict Report

OWNER	Utility	SAWS	Corridor	SW MILITARY	SITE PHOTOS		
	Contact	ANN PECHE	ID	4106			
GENERAL INFO	Utility	WATER					
	Size and Material	STANDARD WATER VALVE, CAST IRON					
	Accessible Route	ASSET IS INSIDE ACCESSIBLE ROUTE					
	Longitudinal or Crossing	CROSSING					
	Placement Relative to ROW	INSIDE ROW					
LOCATION	Sheet No.	130					
	Station	539+65.54					
	Offset	13.98					
	Latitude	+29.357976					
	Longitude	-98.55724					
SUE	Level of Investigation Req'd	NONE					
	Test Hole No	N/A					
	Test Hole Depth	N/A					
RESOLUTION	Recommended Action	MINIMIZE - PROTECT IN PLACE					
	Estimated Resolution Date						
	Resolution Status	UTILITY OWNER INFORMED OF UTILITY

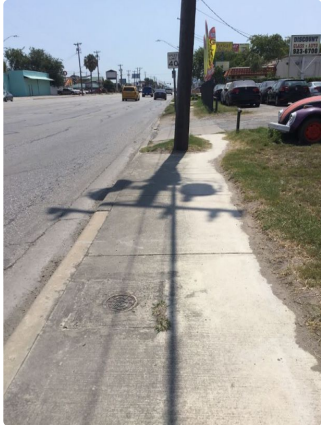
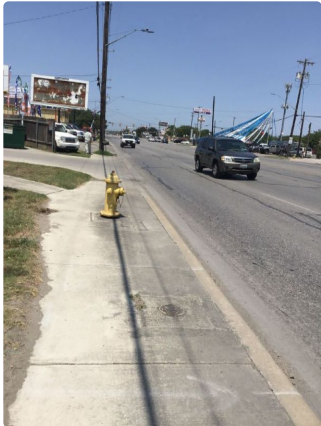
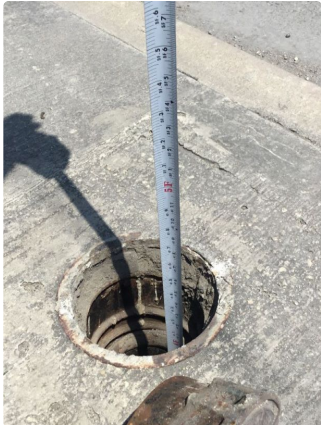
Comment	Bottom of valve to surface = 4'-5" Lid thickness = 2" Back of sidewalk to valve = 4'-4" Sidewalk width = 6' Back of curb to valve = 1'-1"					
	Date Collected		7/23/2018 12:15:56 PM		Date Modified		11/28/2018 6:59:12 AM
