Utility Conflict Report

OWNER	Utility	CPS	Corridor	SW MILITARY	SITE PHOTOS		
	Contact	JAKE MARTINEZ	ID	4116			
GENERAL INFO	Utility	ELECTRIC

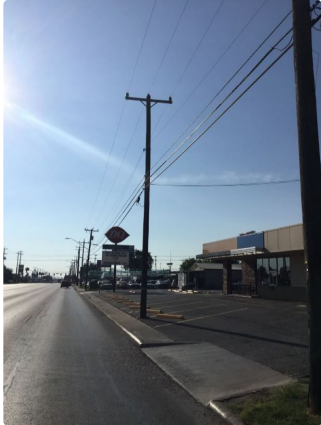
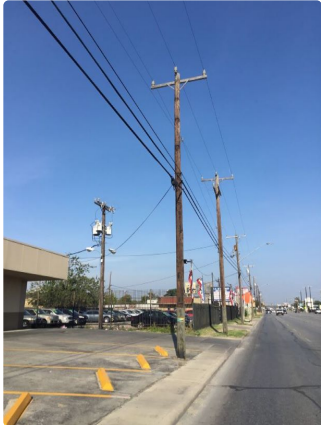
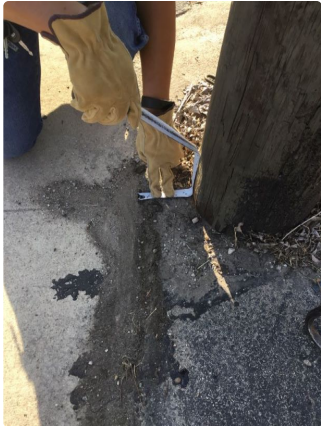
Size and Material	STANDARD POWER POLE, TIMBER					
	Accessible Route	ASSET IS OUTSIDE ACCESSIBLE ROUTE					
	Longitudinal or Crossing	CROSSING					
	Placement Relative to ROW	INSIDE ROW					
LOCATION	Sheet No.	136

Station	558+42.45					
	Offset	15.99					
	Latitude	+29.357397					
	Longitude	-98.55147					
SUE	Level of Investigation Req'd	NONE

Test Hole No	N/A					
	Test Hole Depth	N/A					
RESOLUTION	Recommended Action	NO CONFLICT					
	Estimated Resolution Date						
	Resolution Status	NO RESOLUTION WAS REQUIRED					
	Comment	Pole marking: 44 Pole to back of sidewalk = 5 1/2" Sidewalk width = 2'-11" CATV cable					
Date Collected		7/27/2018 8:54:43 AM		Date Modified		12/18/2018 4:00:04 PM
