Utility Conflict Report

OWNER	Utility	SAWS	Corridor	SW MILITARY	SITE PHOTOS		
	Contact	ANN PECHE	ID	4166			
GENERAL INFO	Utility	WATER					
	Size and Material	STANDARD WATER VALVE, CAST IRON					
	Accessible Route	ASSET IS INSIDE ACCESSIBLE ROUTE					
	Longitudinal or Crossing	CROSSING					
	Placement Relative to ROW	INSIDE ROW					
LOCATION	Sheet No.	158					
	Station	686+13.74					
	Offset	22.19					
	Latitude	+29.356547					
	Longitude	-98.51141					
SUE	Level of Investigation Req'd	NONE					
	Test Hole No	N/A					
	Test Hole Depth	N/A					
RESOLUTION	Recommended Action	NO CONFLICT					
	Estimated Resolution Date						
	Resolution Status	NO RESOLUTION WAS REQUIRED

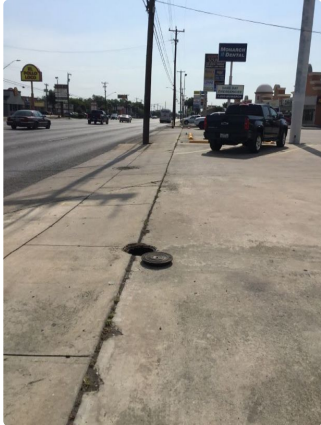
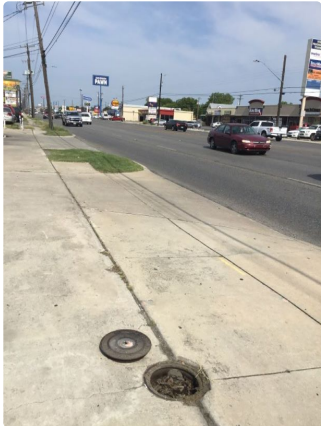
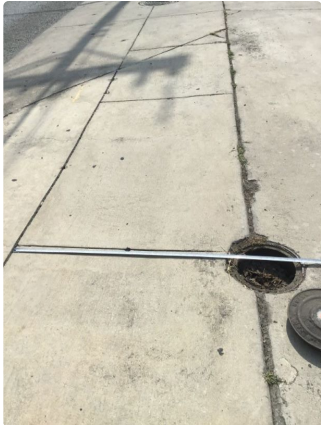
Comment	Front of sidewalk to valve = 3'-6" Sidewalk width = 3'-11" Lid flange thickness = 3/8" Total lid thickness = 1 7/8" Valve box filled with dirt Top of valve to surface = unknown					
Date Collected		8/2/2018 10:31:26 AM		Date Modified		12/18/2018 4:27:07 PM
