## Utility Conflict Report

<b>OWNER</b>	<b>Utility</b>	CPS	<b>Corridor</b>	SW MILITARY	<b>SITE PHOTOS</b>	
	<b>Contact</b>	JAKE MARTINEZ	<b>ID</b>	4180		
<b>GENERAL INFO</b>	<b>Utility</b>	ELECTRIC

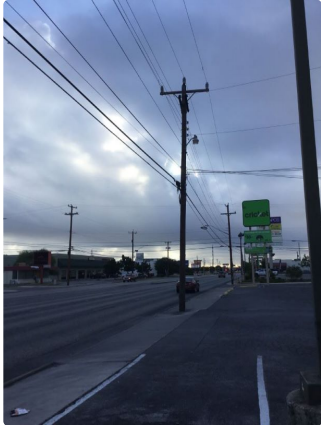
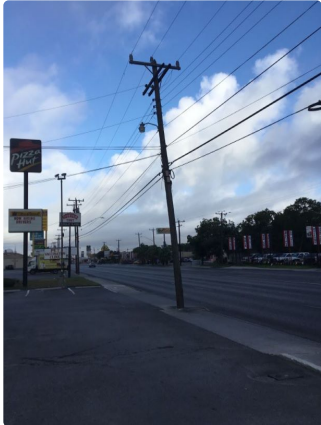
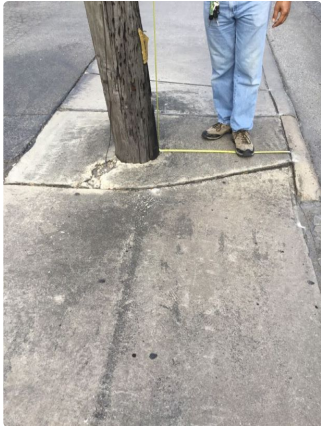
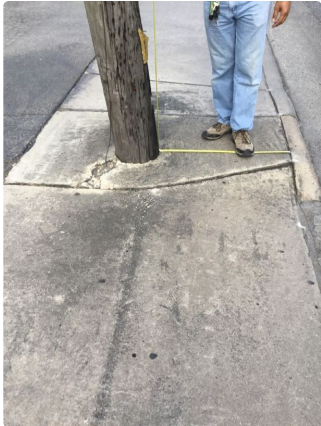
<b>Size and Material</b>	STANDARD POWER POLE, TIMBER				
	<b>Accessible Route</b>	ASSET IS INSIDE ACCESSIBLE ROUTE				
	<b>Longitudinal or Crossing</b>	CROSSING				
	<b>Placement Relative to ROW</b>	INSIDE ROW				
<b>LOCATION</b>	<b>Sheet No.</b>	160

<b>Estimated Resolution Date</b>					
	<b>Resolution Status</b>	NO RESOLUTION WAS REQUIRED				
	<b>Comment</b>	Pole ID: 371579 Pole to back of curb = 2'-10 1/2" Sidewalk width = 5'-11" Pole to back of sidewalk = 2'-1"

<b>Test Hole No</b>	N/A				
	<b>Test Hole Depth</b>	N/A				
<b>RESOLUTION</b>	<b>Recommended Action</b>	NO CONFLICT
