## Utility Conflict Report

<b>OWNER</b>	<b>Utility</b>	SAWS	<b>Corridor</b>	SW MILITARY	<b>SITE PHOTOS</b>		
	<b>Contact</b>	ANN PECHE	<b>ID</b>	4210			
<b>GENERAL INFO</b>	<b>Utility</b>	WATER

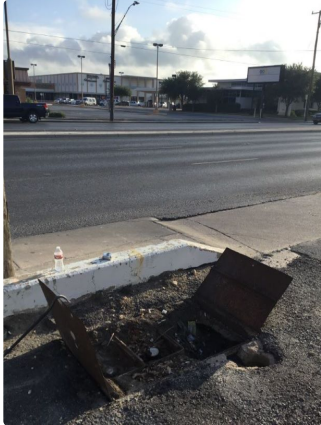
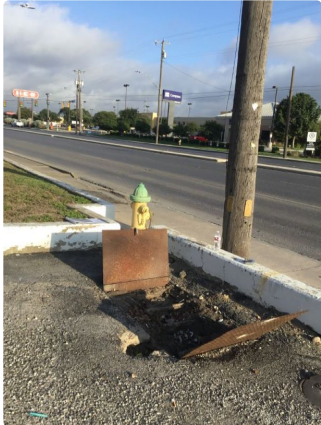
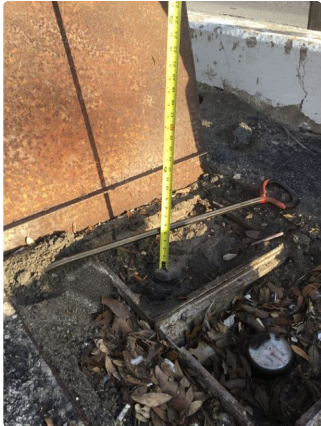
<b>Size and Material</b>	STANDARD WATER METER, CAST IRON					
	<b>Accessible Route</b>	ASSET IS OUTSIDE ACCESSIBLE ROUTE					
	<b>Longitudinal or Crossing</b>	CROSSING					
	<b>Placement Relative to ROW</b>	INSIDE ROW					
<b>LOCATION</b>	<b>Sheet No.</b>	166

<b>Test Hole No</b>	N/A					
	<b>Test Hole Depth</b>	N/A					
<b>RESOLUTION</b>	<b>Recommended Action</b>	NO CONFLICT					
	<b>Estimated Resolution Date</b>						
	<b>Resolution Status</b>	NO RESOLUTION WAS REQUIRED					
	<b>Comment</b>	Back of wall to meter = 1'-9" Top of meter to surface = 4" Sidewalk width = 6'-8"
