Utility Conflict Report

OWNER	Utility	CPS	Corridor	SW MILITARY	SITE PHOTOS	
	Contact	JAKE MARTINEZ	ID	4213		
GENERAL INFO	Utility	ELECTRIC

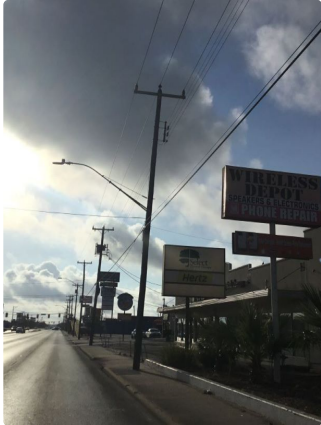
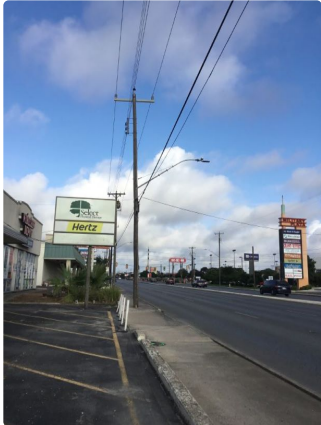
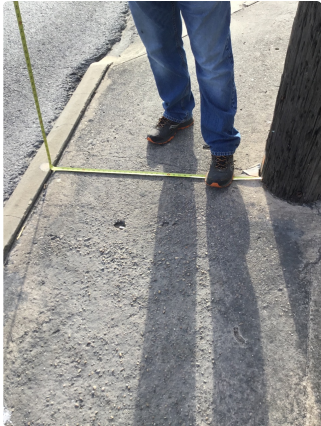
Size and Material	STANDARD POWER POLE, TIMBER				
	Accessible Route	ASSET IS INSIDE ACCESSIBLE ROUTE				
	Longitudinal or Crossing	CROSSING				
	Placement Relative to ROW	INSIDE ROW				
LOCATION	Sheet No.	166

Station	720+96.71				
	Offset	15.62				
	Latitude	+29.356581				
	Longitude	-98.50049				
SUE	Level of Investigation Req'd	NONE

Test Hole No	N/A				
	Test Hole Depth	N/A				
RESOLUTION	Recommended Action	NO CONFLICT				
	Estimated Resolution Date	11/21/2018				
	Resolution Status	NO RESOLUTION WAS REQUIRED				
	Comment	Pole ID: LW 57288 405127 Back of curb to pole = 3'-2" Sidewalk width = 6'-3" Back of sidewalk to pole = 2'-2"				
Date Collected		8/7/2018 8:25:08 AM		Date Modified	11/28/2018 6:59:12 AM
