Utility Conflict Report

OWNER	Utility	CPS	Corridor	SW MILITARY	SITE PHOTOS		
	Contact	JAKE MARTINEZ	ID	7030			
GENERAL INFO	Utility	ELECTRIC

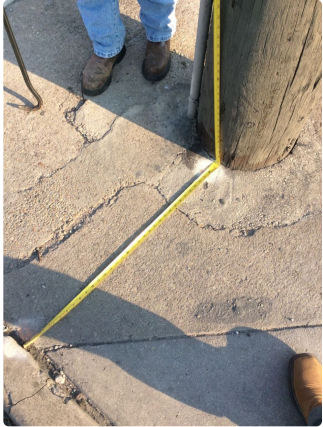
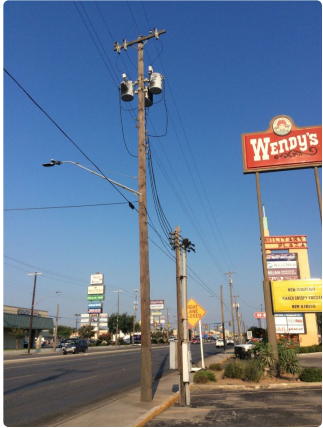
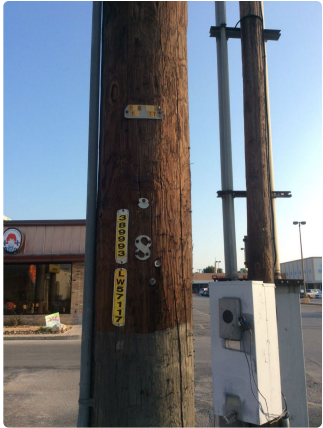
Size and Material	STANDARD POWER POLE, TIMBER					
	Accessible Route	ASSET IS INSIDE ACCESSIBLE ROUTE					
	Longitudinal or Crossing	CROSSING					
	Placement Relative to ROW	INSIDE ROW					
LOCATION	Sheet No.	212

Station	950+54.82					
	Offset	-17.68					
	Latitude	+29.356918					
	Longitude	-98.50067					
SUE	Level of Investigation Req'd	NONE

Test Hole No	N/A					
	Test Hole Depth	N/A					
RESOLUTION	Recommended Action	NO CONFLICT					
	Estimated Resolution Date	11/21/2018					
	Resolution Status	NO RESOLUTION WAS REQUIRED					
	Comment	Pole diameter = 12" Back of curb to pole = 2' 10" Pole to front of wall = 1'-10"					
Date Collected		8/3/2018 8:21:46 AM		Date Modified		11/28/2018 6:59:12 AM
