Utility Conflict Report

OWNER	Utility	SAWS	Corridor	SW MILITARY	SITE PHOTOS	
	Contact	ANN PECHE	ID	7072		
GENERAL INFO	Utility	WATER

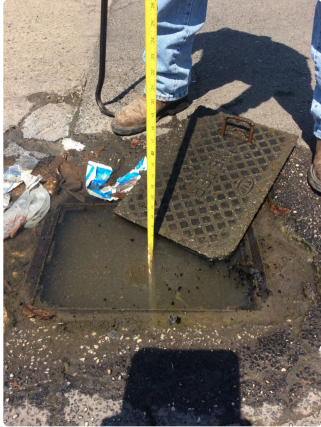
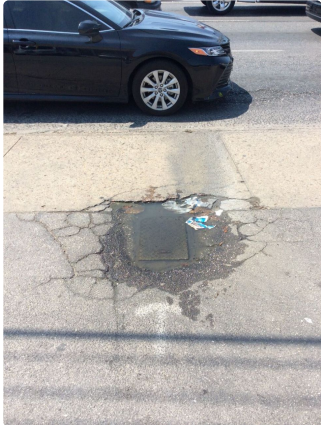
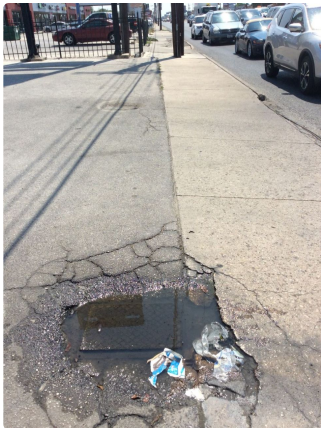
Size and Material	STANDARD WATER METER, STEEL				
	Accessible Route	ASSET IS OUTSIDE ACCESSIBLE ROUTE				
	Longitudinal or Crossing	CROSSING				
	Placement Relative to ROW	INSIDE ROW

Estimated Resolution Date					
	Resolution Status	UTILITY OWNER INFORMED OF UTILITY				
	Comment	Meter filled with water Meter adjacent to driveway joint Top of meter to surface = 6"				
Date Collected		8/3/2018 11:49:19 AM		Date Modified	11/28/2018 6:59:12 AM

Test Hole No	N/A				
	Test Hole Depth	N/A				
RESOLUTION	Recommended Action	MINIMIZE - PROTECT IN PLACE
