Utility Conflict Report

OWNER	Utility	CPS	Corridor	SW MILITARY	SITE PHOTOS		
	Contact	JAKE MARTINEZ	ID	7075			
GENERAL INFO	Utility	ELECTRIC

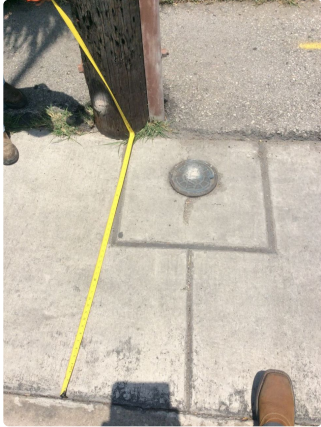
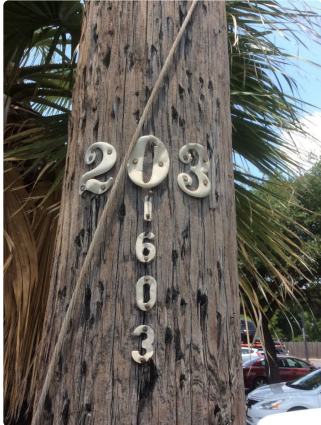
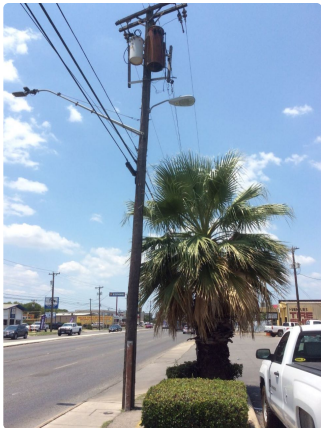
Size and Material	STANDARD POWER POLE, TIMBER					
	Accessible Route	ASSET IS INSIDE ACCESSIBLE ROUTE					
	Longitudinal or Crossing	CROSSING					
	Placement Relative to ROW	INSIDE ROW					
LOCATION	Sheet No.	202

Test Hole No	N/A					
	Test Hole Depth	N/A					
RESOLUTION	Recommended Action	NO CONFLICT					
	Estimated Resolution Date						
	Resolution Status	NO RESOLUTION WAS REQUIRED					
	Comment	Pole marking: 203; 603 Back of curb to pole = 3'-10" Pole to back of asphalt strip = 3'-0" Pole diameter = 10"					
Date Collected		8/3/2018 1:24:29 PM		Date Modified		12/18/2018 4:01:55 PM
