Utility Conflict Report

OWNER	Utility	SAWS	Corridor	SW MILITARY	SITE PHOTOS		
	Contact	ANN PECHE	ID	7096			
GENERAL INFO	Utility	WATER

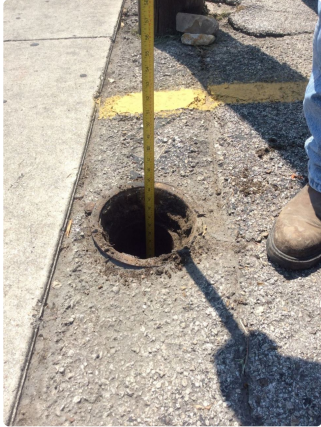
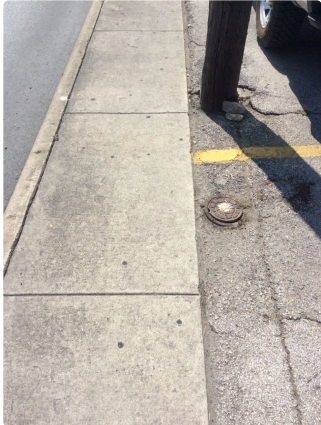
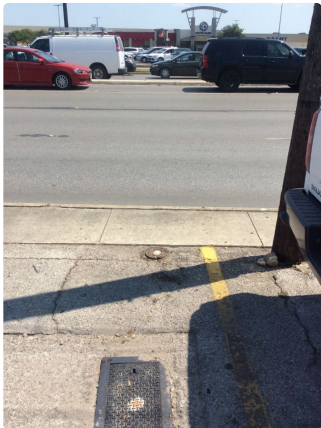
Size and Material	STANDARD WATER VALVE, CAST IRON					
	Accessible Route	ASSET IS OUTSIDE ACCESSIBLE ROUTE					
	Longitudinal or Crossing	CROSSING					
	Placement Relative to ROW	INSIDE ROW					
LOCATION	Sheet No.	195

Station	857+49.88					
	Offset	-16.49					
	Latitude	+29.356708					
	Longitude	-98.52988					
SUE	Level of Investigation Req'd	NONE

Test Hole No	N/A					
	Test Hole Depth	N/A					
RESOLUTION	Recommended Action	NO CONFLICT					
	Estimated Resolution Date						
	Resolution Status	NO RESOLUTION WAS REQUIRED					
	Comment	Back of sidewalk to valve = 2" Sidewalk width = 3'-0" Top of valve to surface = 3'-6" Lid thickness = 2"					
Date Collected		8/3/2018 3:28:40 PM		Date Modified		12/19/2018 11:31:24 AM
