Utility Conflict Report

OWNER	Utility	CPS	Corridor	SW MILITARY	SITE PHOTOS		
	Contact	JAKE MARTINEZ	ID	7106			
GENERAL INFO	Utility	ELECTRIC

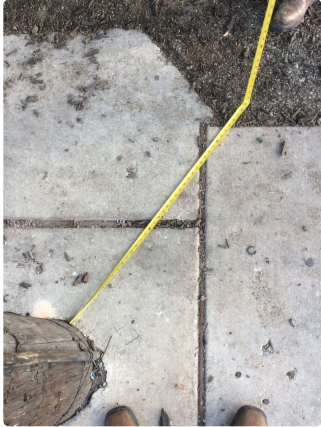
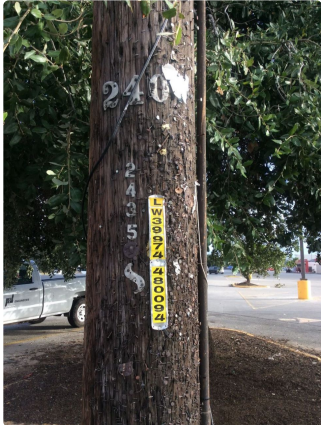
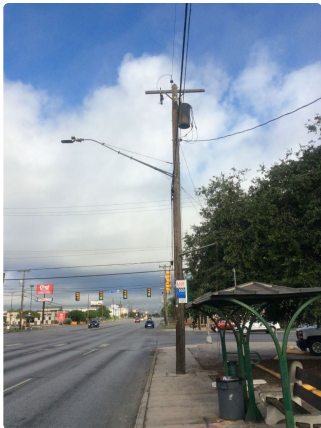
Size and Material	STANDARD POWER POLE, TIMBER					
	Accessible Route	ASSET IS INSIDE ACCESSIBLE ROUTE					
	Longitudinal or Crossing	CROSSING					
	Placement Relative to ROW	INSIDE ROW					
LOCATION	Sheet No.	198

Comment	Pole ID: 480094; LW39974 Pole marking: 240; 2435 Pole to back of sidewalk = 2'-10" Back of curb to pole = 2'-9" Guy wire at back of sidewalk Pole diameter = 12" Adjacent to existing VIA bus stop					
Date Collected		8/6/2018 8:13:25 AM		Date Modified		12/18/2018 4:02:02 PM

Test Hole No	N/A					
	Test Hole Depth	N/A					
RESOLUTION	Recommended Action	NO CONFLICT					
	Estimated Resolution Date						
	Resolution Status	NO RESOLUTION WAS REQUIRED
