Utility Conflict Report

| OWNER | Utility | CPS | Corridor | SW MILITARY | SITE PHOTOS |
| | Contact | JAKE MARTINEZ | ID | 7070 | |

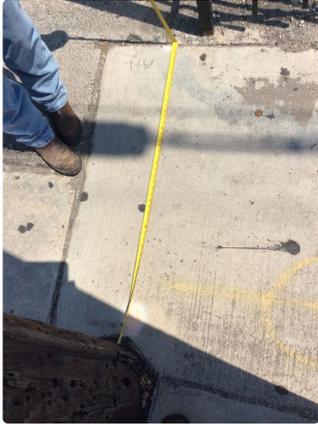
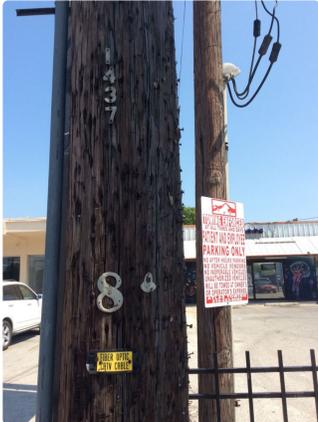
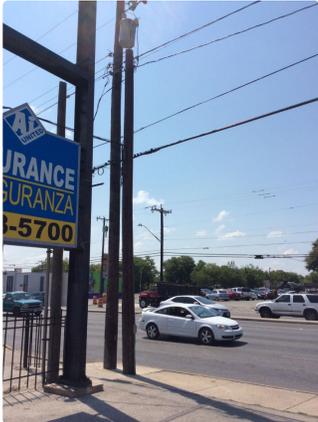
| GENERAL INFO | Utility | ELECTRIC | | | |
| | Size and Material | STANDARD POWER POLE, TIMBER | | | |
| | Accessible Route | ASSET IS INSIDE ACCESSIBLE ROUTE | | | |
| | Comment | Pole marking: 8 Pole diameter = 10" Pole to back of sidewalk = 3'-11" Back of curb to pole = 3'-1" CATV cable Dead end pole to be removed, attachments to be relocated with ID 7069 | | | |

| RESOLUTION | Recommended Action | ACCOMODATE - RELOCATION | | | |
